Home Report

Scottish Single Survey

Single Survey

Property address	0/1 20 Whimbrel Wynd Renfrew PA4 8TL
Customer	Mr Fraser Walker
Customer address	0/1 20 Whimbrel Wynd Renfrew PA4 8TL
Prepared by	Shepherd Chartered Surveyors
Date of inspection	20/02/2026

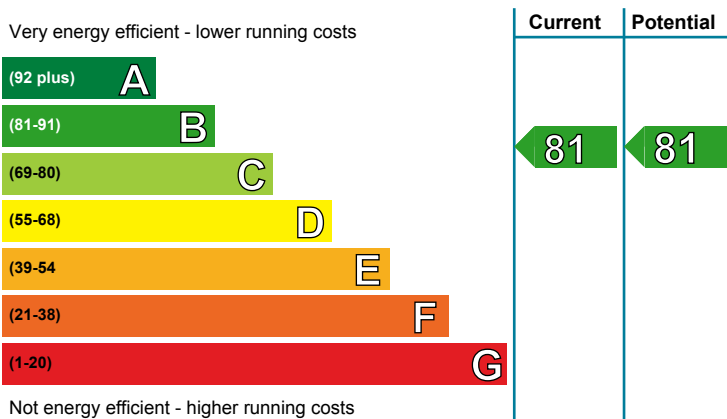
Energy Efficiency Rating

This graph shows the current efficiency of your home, taking into account both energy efficiency and fuel costs. The higher this rating, the lower your fuel bills are likely to be.

Your current rating is **band B (81)**. The average rating for EPCs in Scotland is **band D (61)**.

The potential rating shows the effect of undertaking all of the improvement measures listed within your recommendations report.
